PROJECT: Manhole Rehabilitation

OWNER: County of Santa Barbara / Laguna Sanitation District

Epoxytec Products Make Manhole Rehab Easy

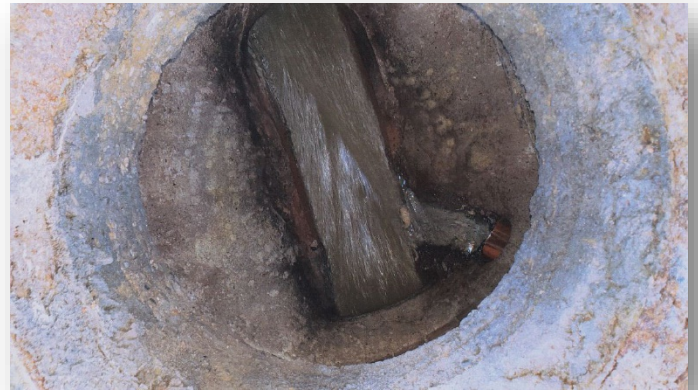
In Santa Barbara, CA, four brick and concrete manholes needed rehabilitation due to minor root intrusions and mild body deterioration caused by gas exposure. There was no outside water intrusion, so this was an easy rehab project for contractor V. Lopez Jr. & Sons G.E.C., Inc., provider of general engineering contracting services throughout California and the Central Coast since 1979. Using Epoxytec's manhole rehab solutions would make this manhole rehab project straightforward.
